petco PETCO "GREENVILLE, TX"
 PETCO ANIMAL SUPPLIES STORES, INC. 6834 WESLEY STREET
 GREENVILLE, TX
AN AMERICAN FELLOWES DRIVE, GREENVILLE, TEXAS 75040

DRAWING TITLE:
DETAILS
A6.1

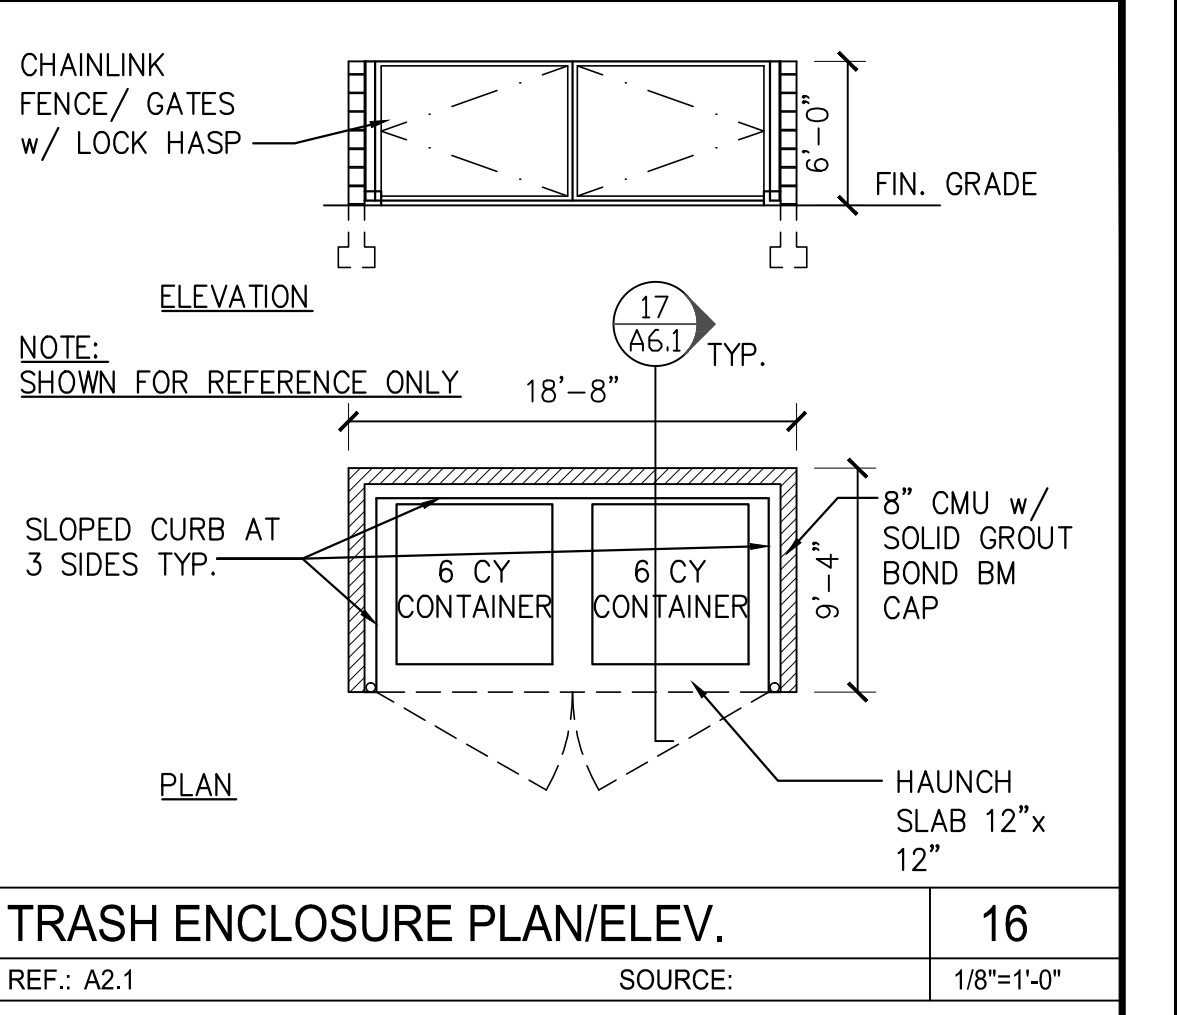
TRASH ENCLOSURE PLAN/ELEV. 16
 REF.: A2.1 SOURCE: 1/8"=1'-0"

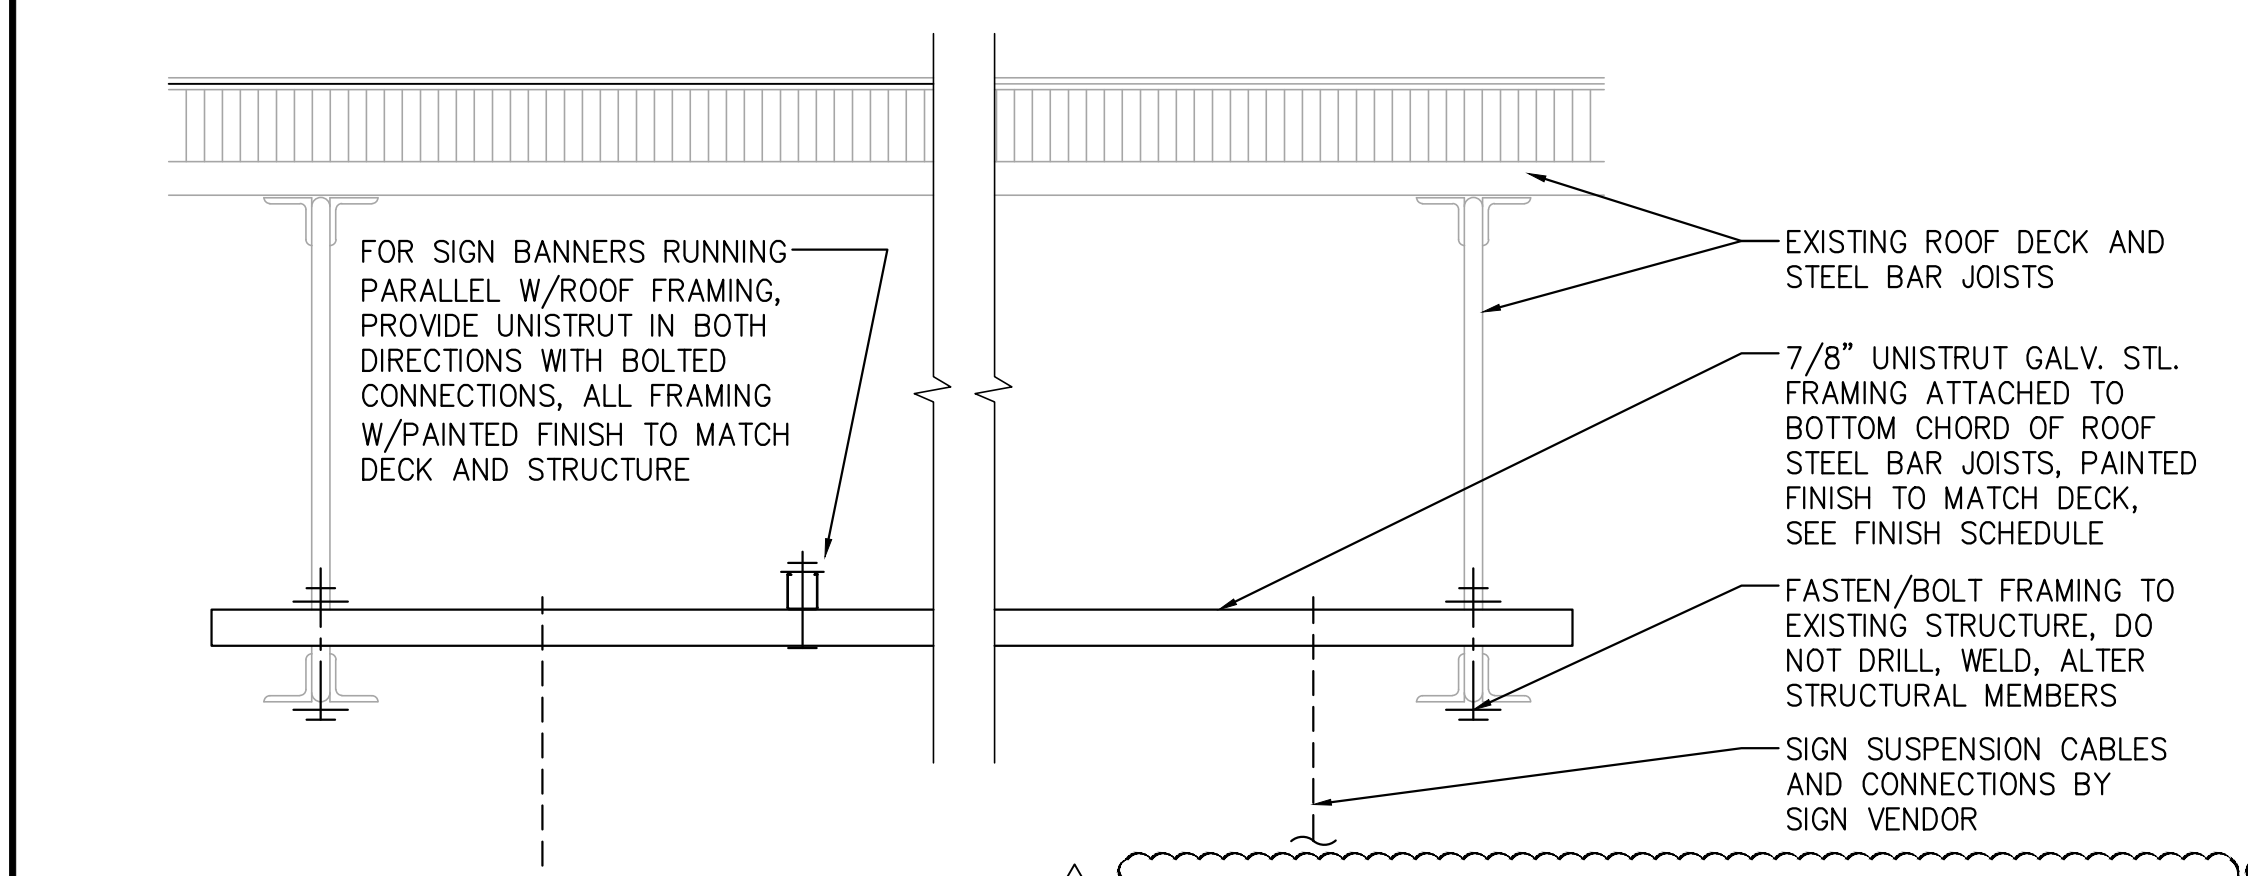
BANNER SIGN SUPPORT DETAIL 14
 REF.: A2.4 SOURCE: 1 1/2"=1'-0"

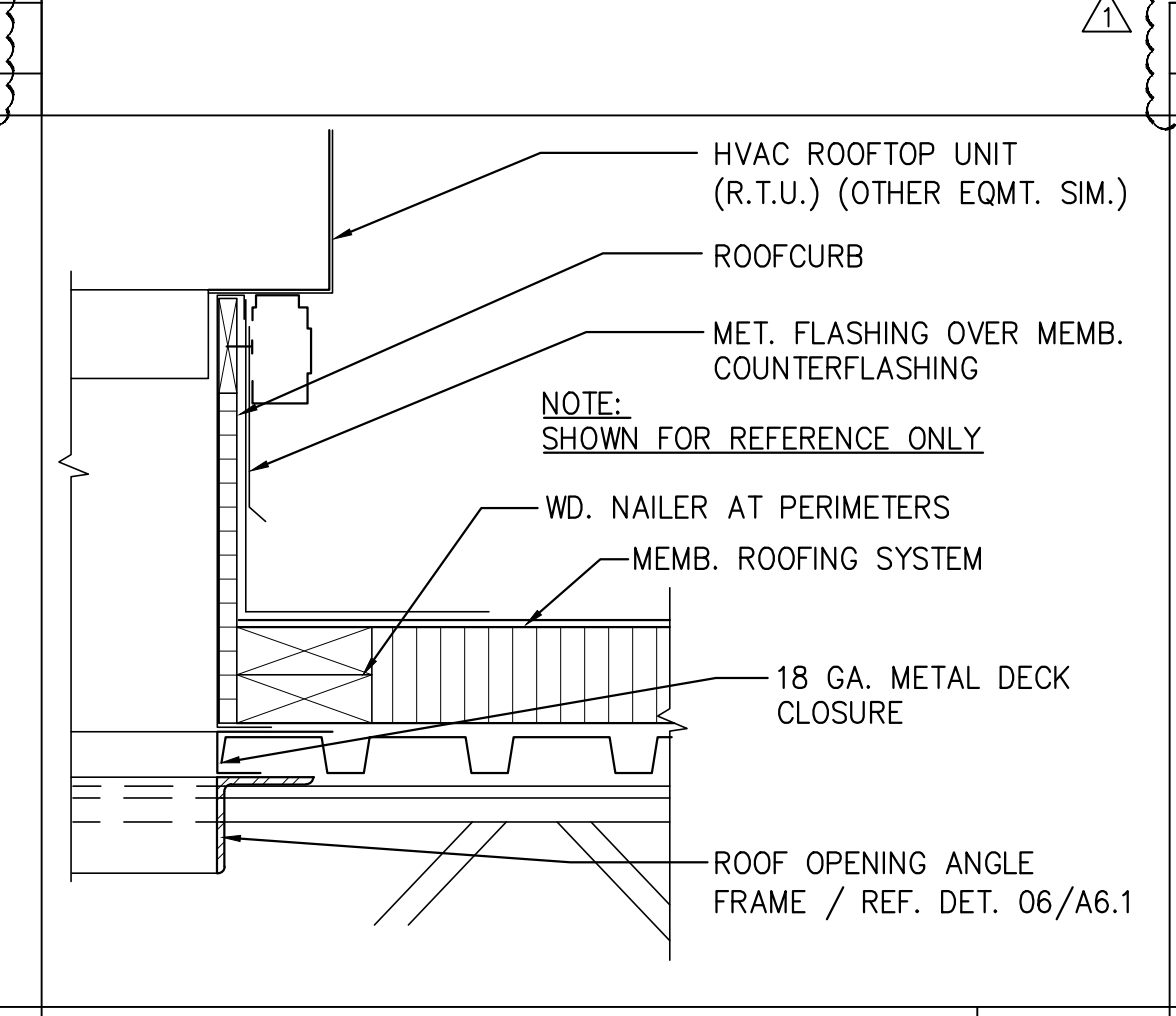
ROOF CURB DETAIL 07
 REF.: A2.5 SOURCE: 1 1/2"=1'-0"

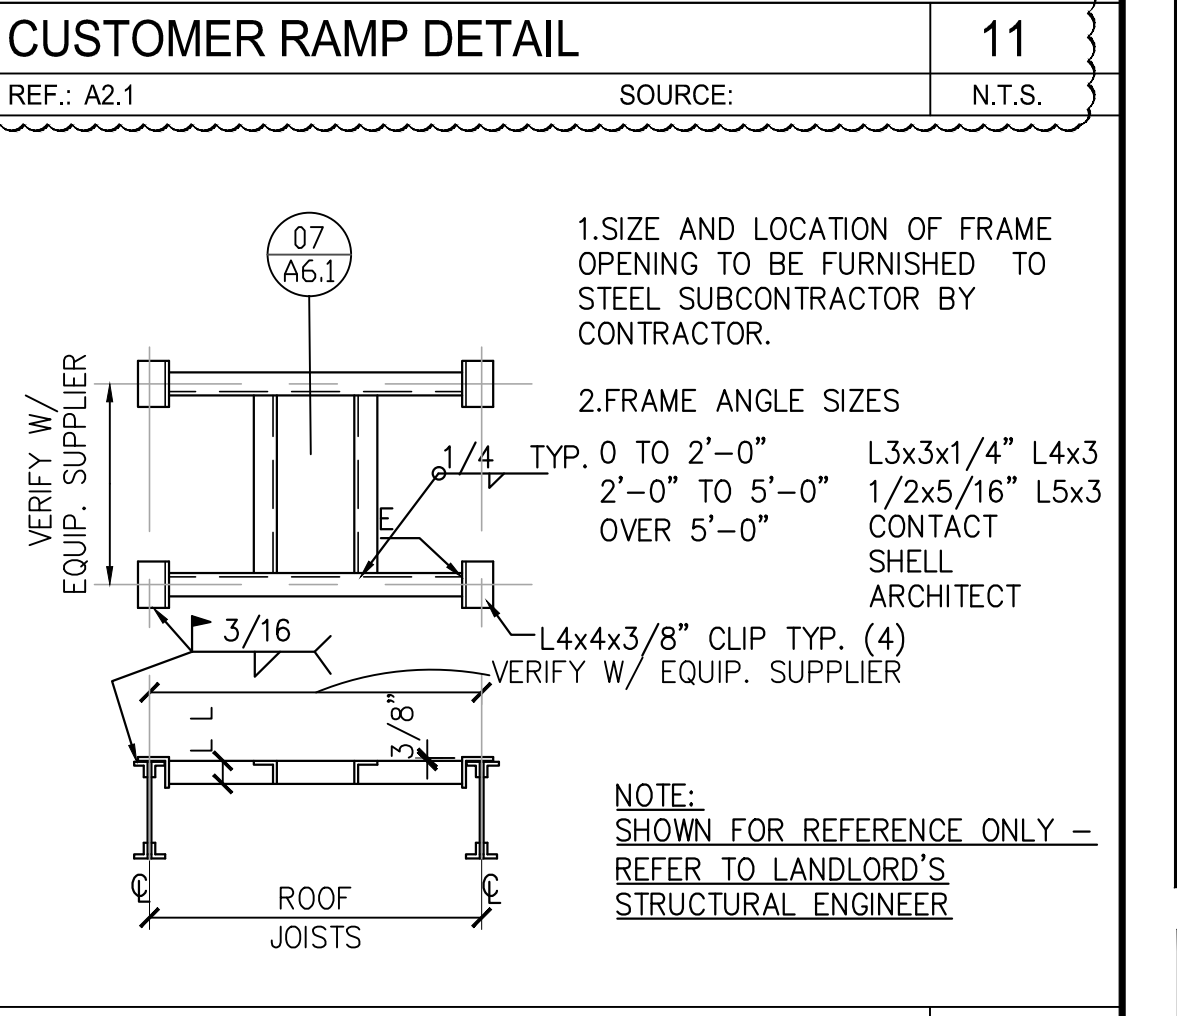
ROOF ANGLE FRAME DETAIL 06
 REF.: A2.5 SOURCE: N.T.S.

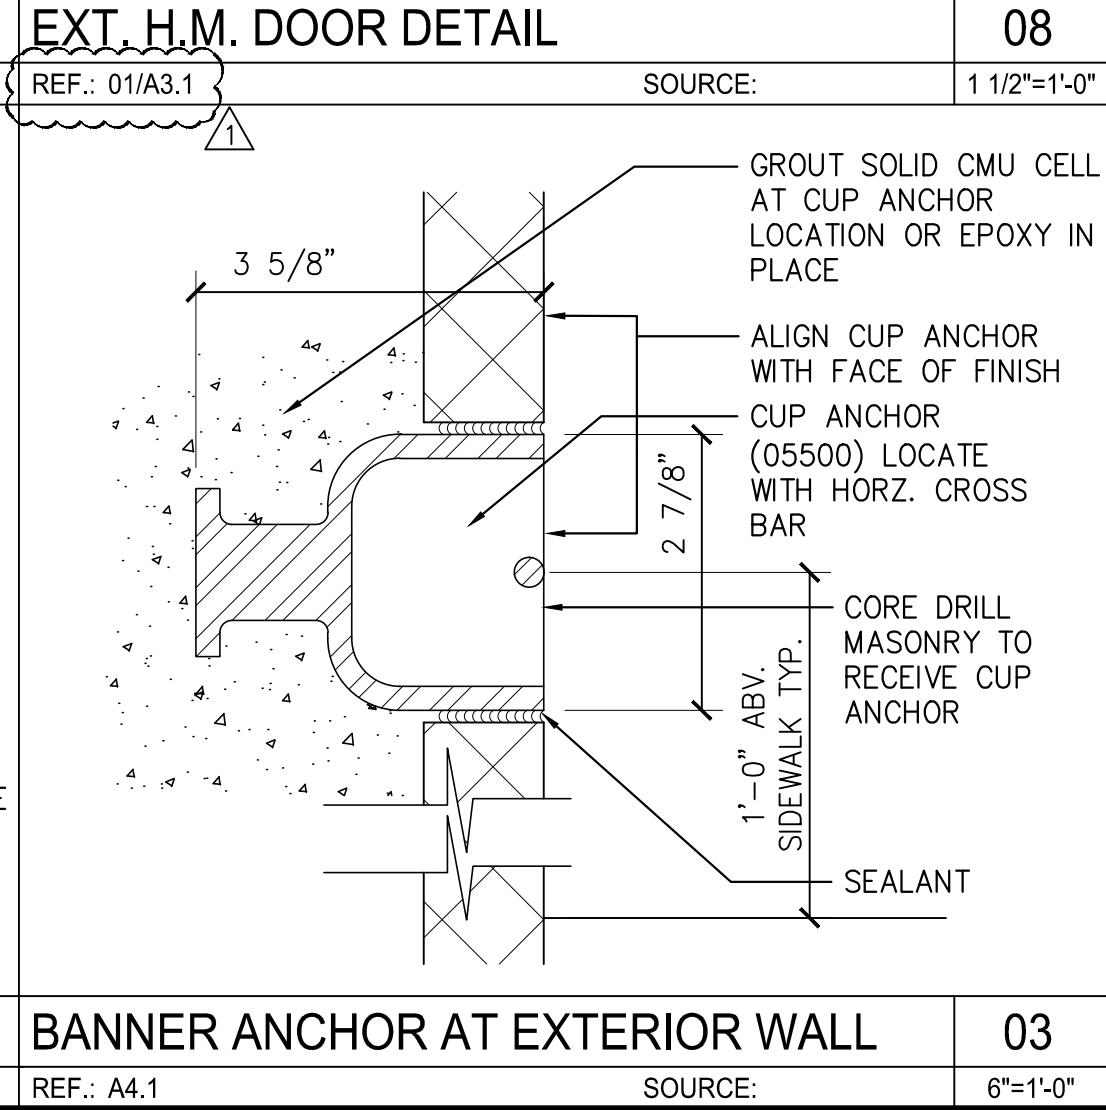
BANNER ANCHOR AT EXTERIOR WALL 03
 REF.: A4.1 SOURCE: 6"=1'-0"

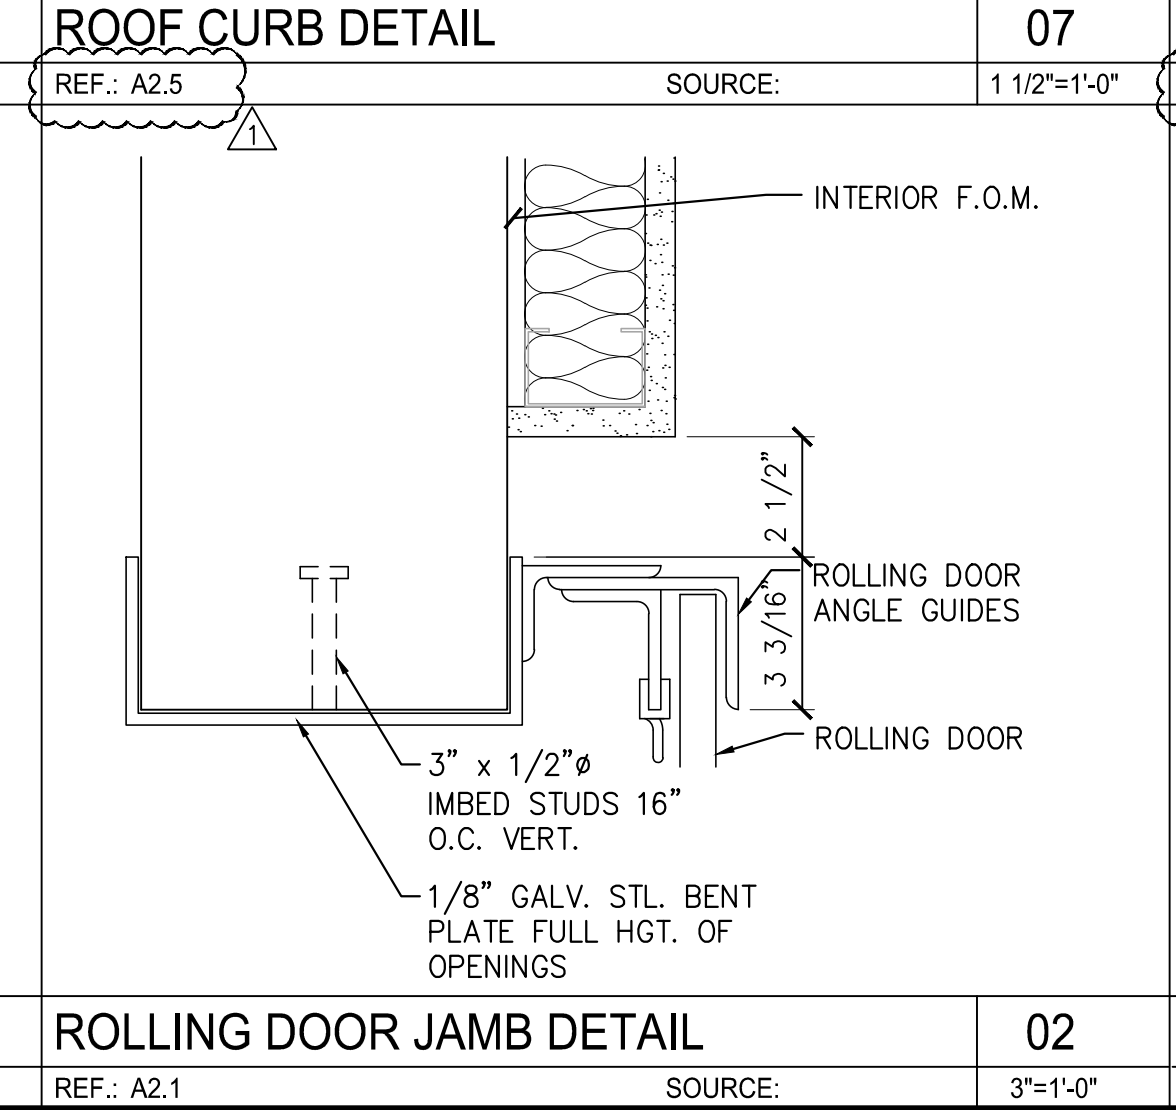
ROLLING DOOR JAMB DETAIL 02
 REF.: A2.1 SOURCE: 3"=1'-0"

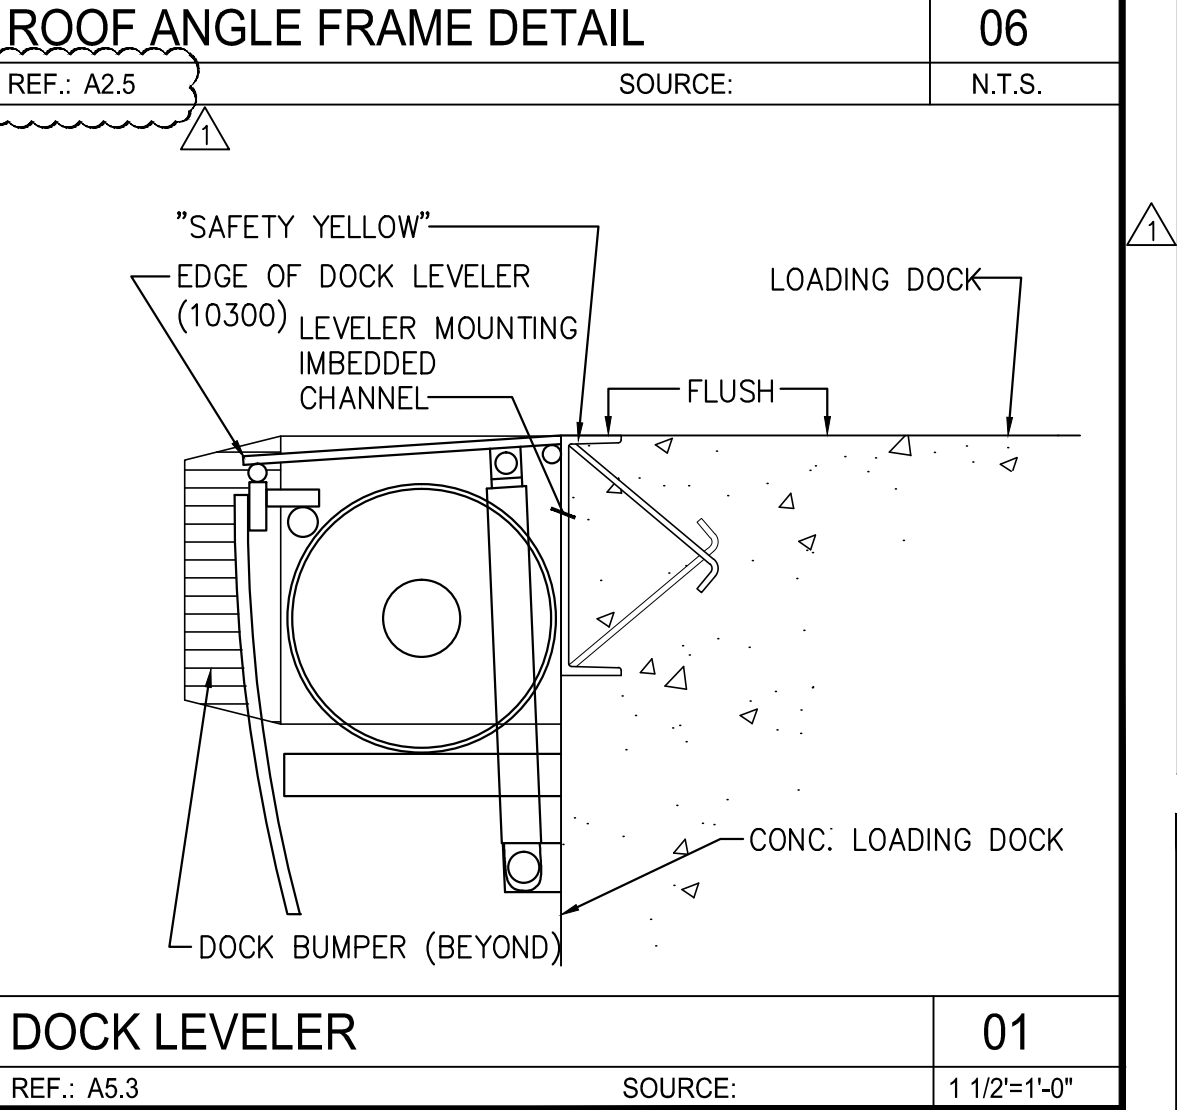
DOCK LEVELER 01
 REF.: A5.3 SOURCE: 1 1/2"=1'-0"
